Montana Department of Transportation (MDT)
Performance Prediction Models

Performance Prediction Models

PROJECT HWY-30604 DT
September 6, 2007

Fugro Consultants, Inc.
Applied Research Associates, Inc.

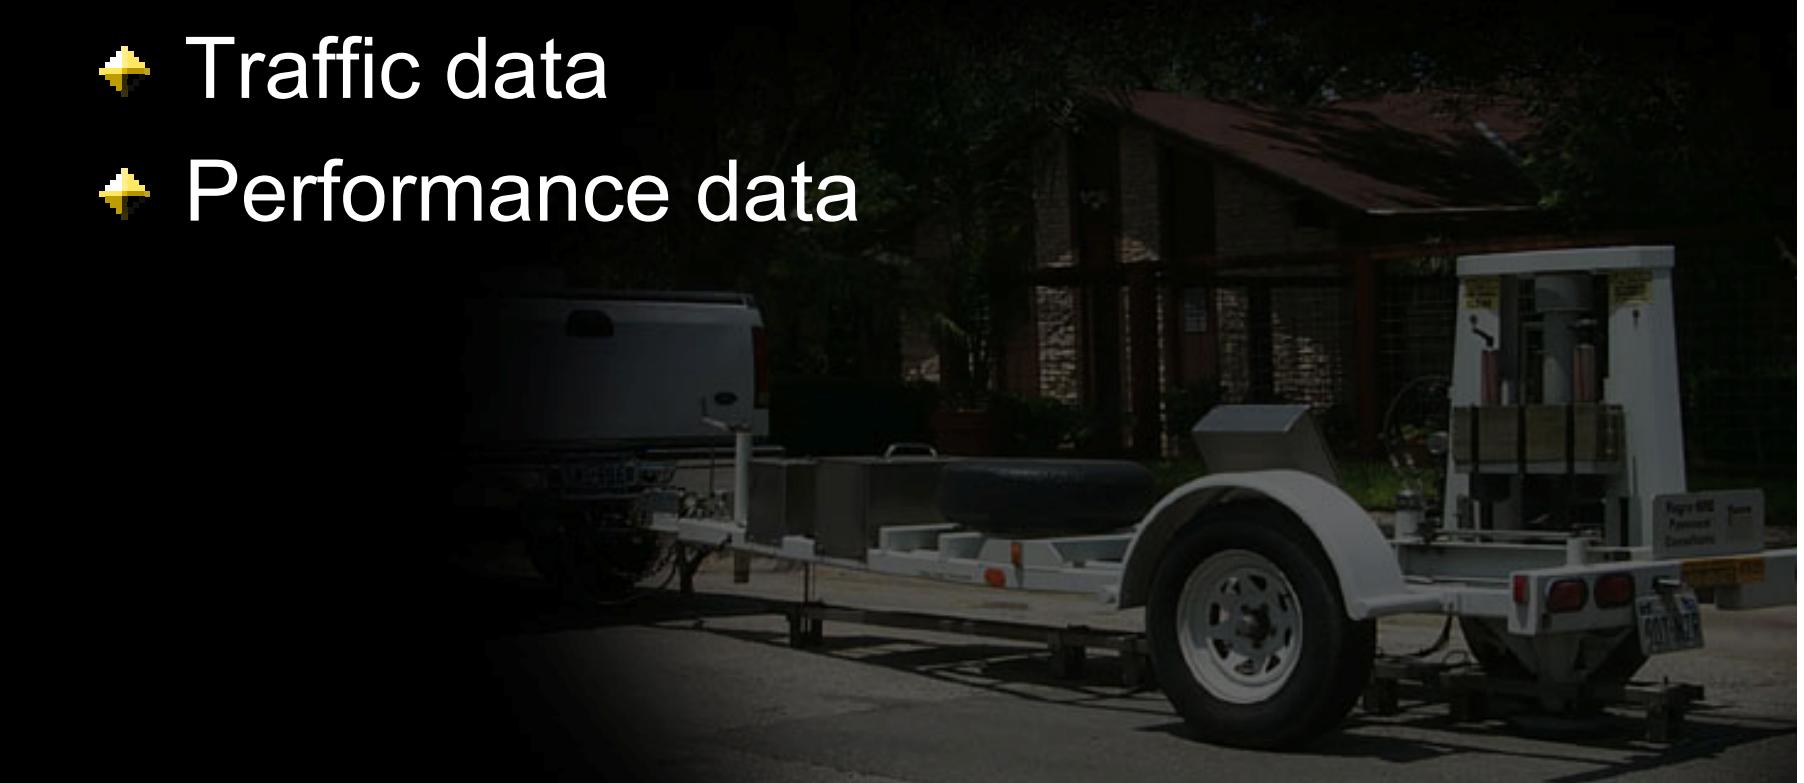
Calibration/Validation Database

- ◆ Section identification and layer data
- ◆ Pavement materials data
- ◆ Traffic data
- ◆ Performance data

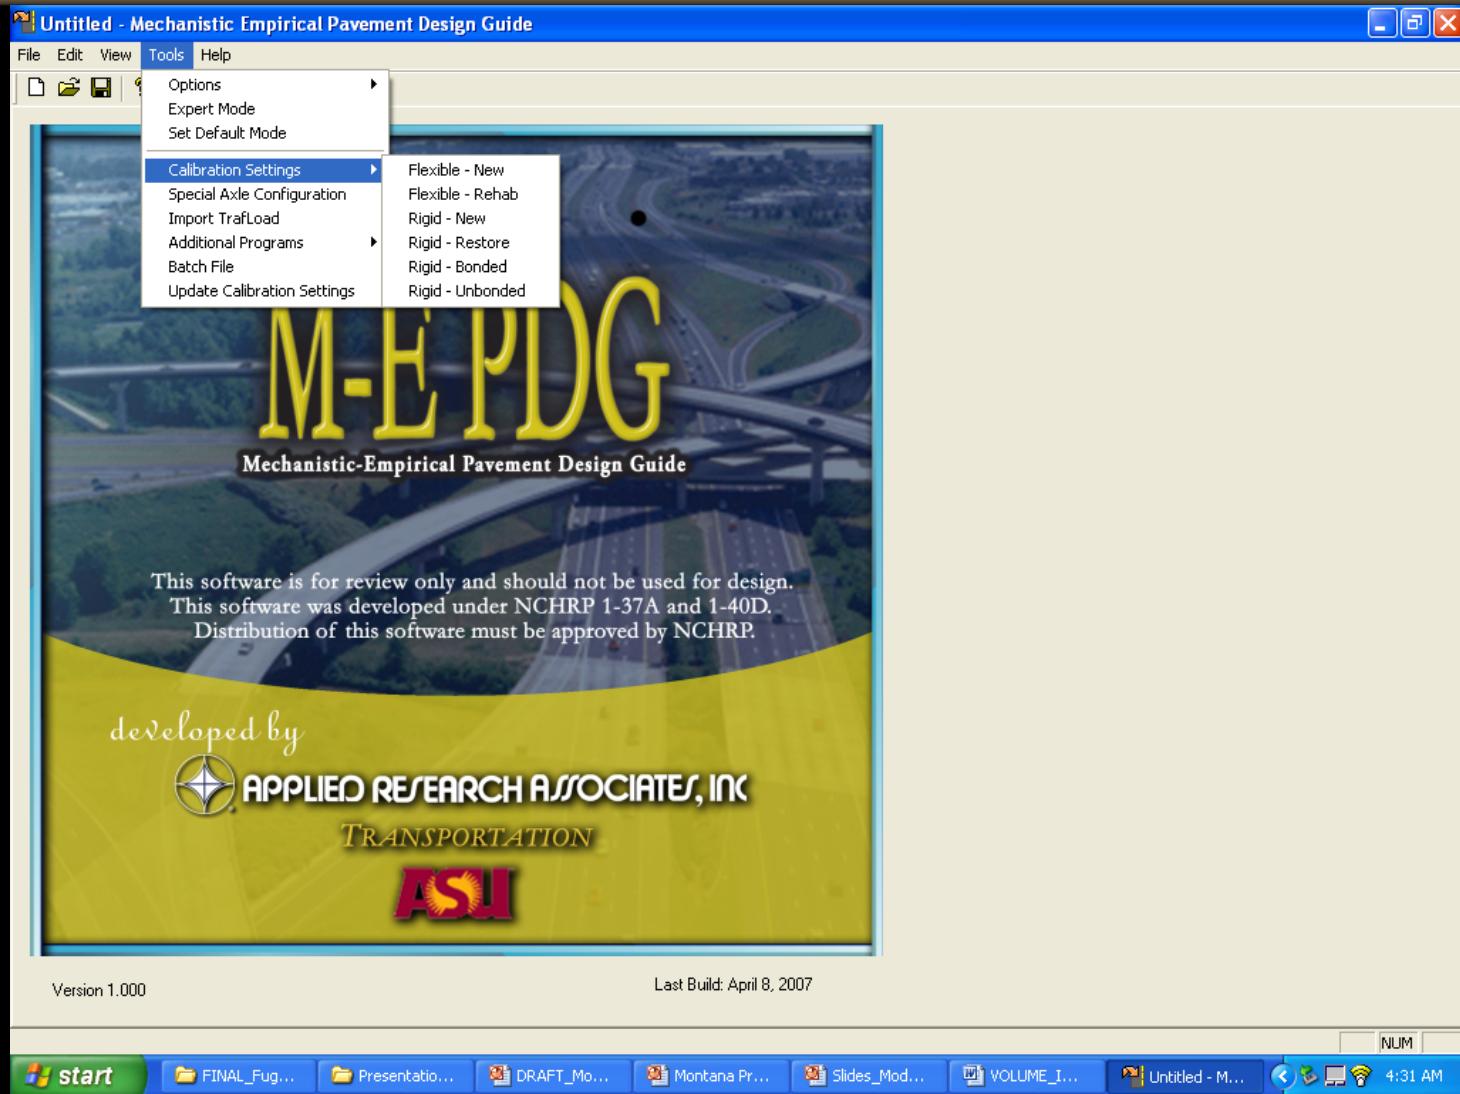
Tools Menu, Drop-Down Box

Distress Model Calibration Settings - Flexible New

$\delta_a(N) = \beta_{s_1} \varepsilon_r h \left(\frac{\varepsilon_o}{\varepsilon_r} \right) e^{-\left(\frac{\rho}{N}\right)^{\beta}}$

δ_a = permanent deformation for the layer
 N = number of repetitions
 ε_o = average vertical strain (in/in)
 h = thickness of the layer (in)
 $\varepsilon_o, \beta, \rho$ = material properties
 ε_r = resilient strain (in/in)

0.20 Granular: k1: 2.03 Bs1: **1**

0.20 Fine-grain: k1: 1.35 Bs1: **1**

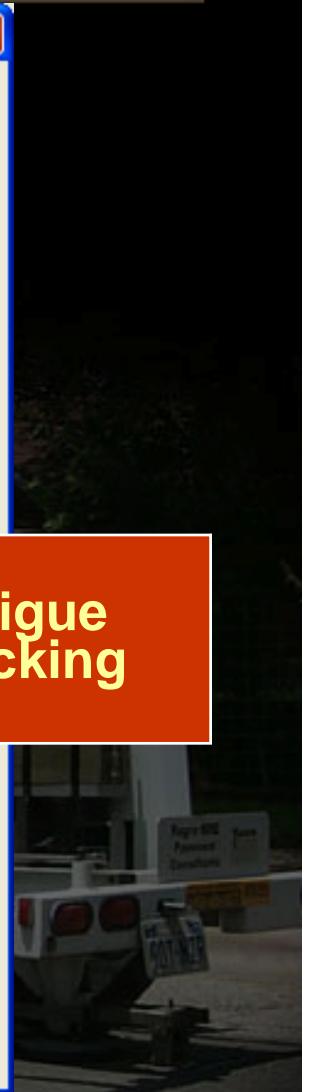
Fatigue Cracking

Endurance limit for calculation of HMA Fatigue Damage

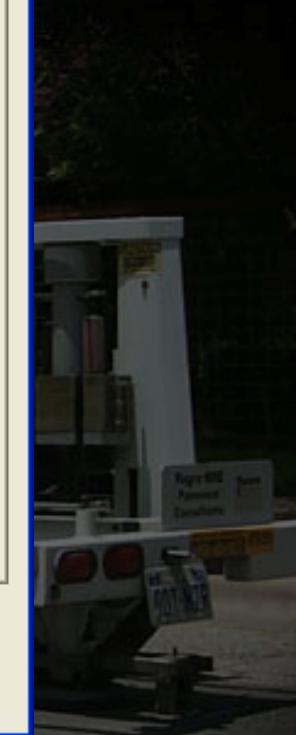
AC Top Down Cracking

$$FC_{top} = \left(\frac{C_4}{1 + e^{(C_1 - C_2) * \log_{10}(Damage)}} \right) * 10.56$$

AC Bottom Up Cracking

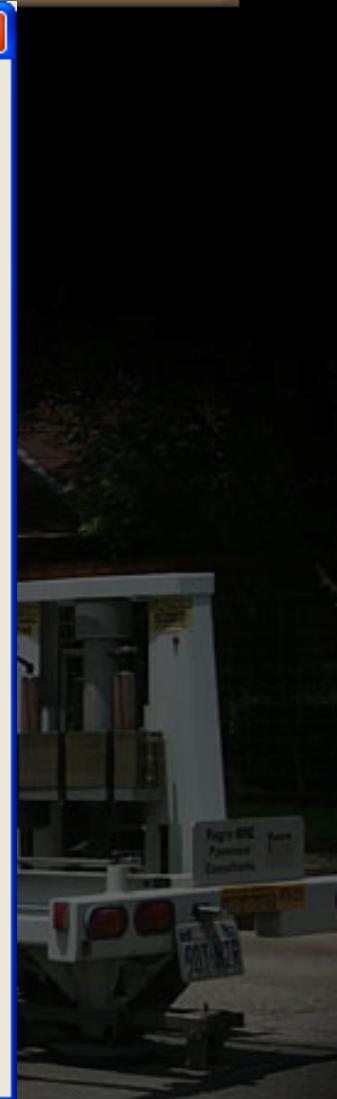
N_f = number of repetitions to fatigue cracking
 σ_s = Tensile stress (psi)
 M_r = modulus of rupture (psi)

Fatigue Cracking of Semi-Rigid Pavements
